Monitoring Report

Facility Name: Hyland Landfill

Facility Number: 02S17

Date: December 31, 2012

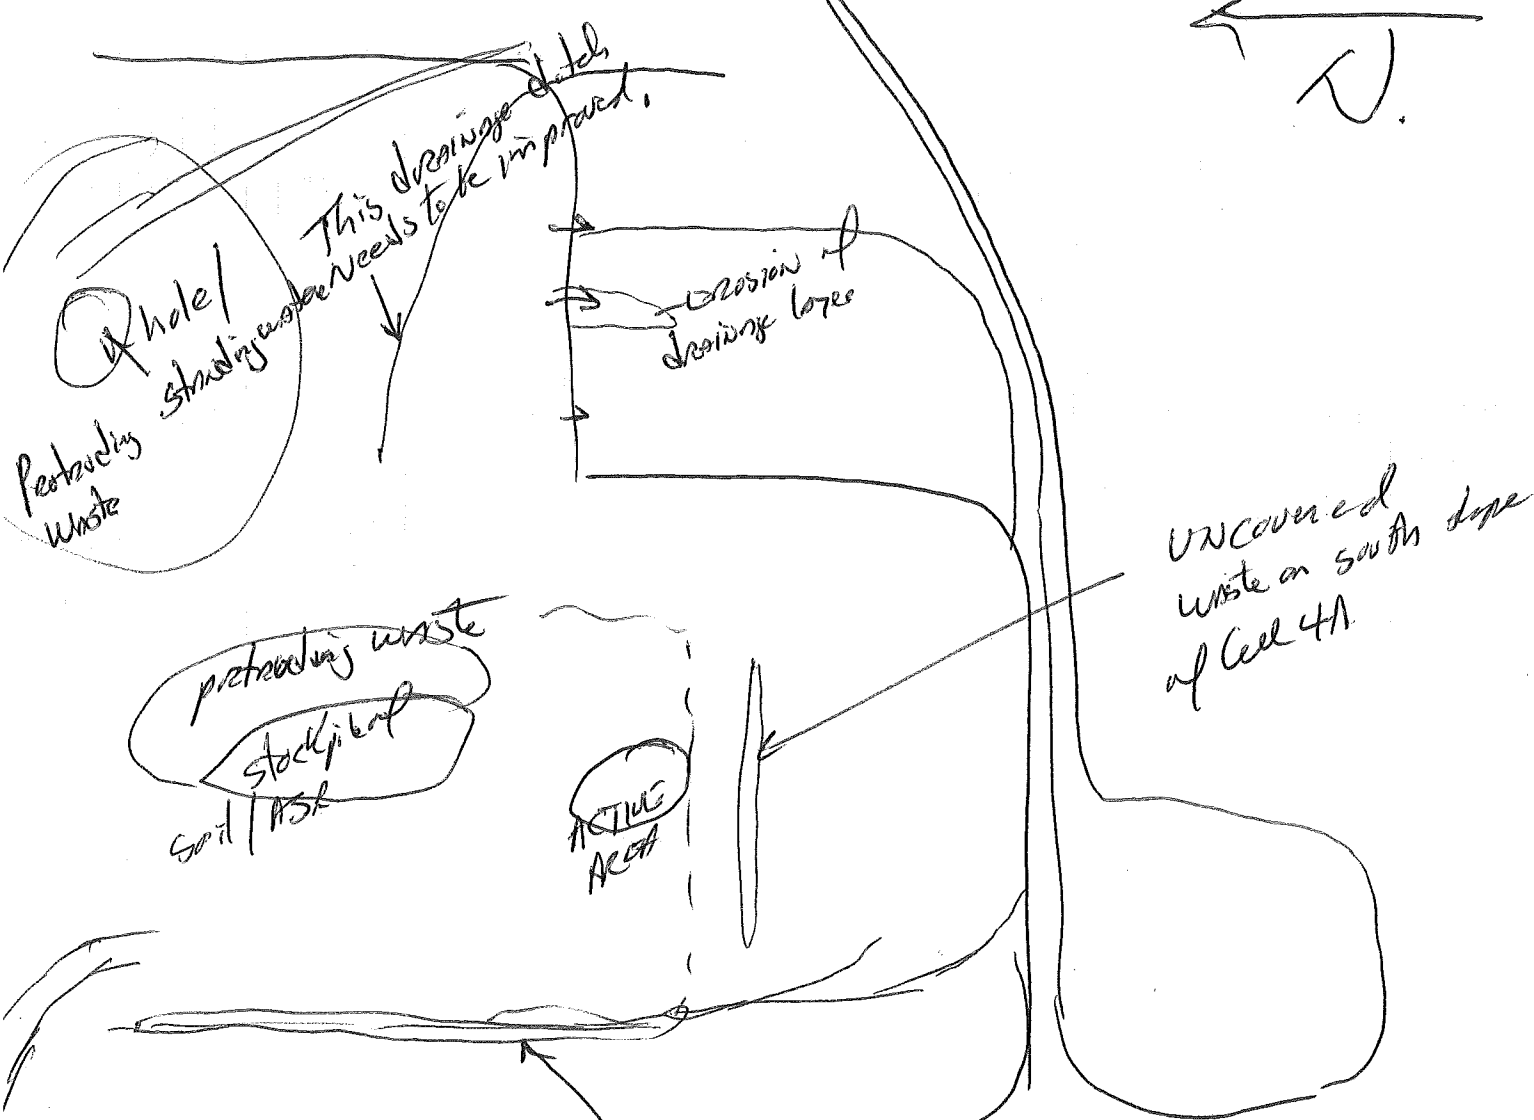
- c. Tanks. 360-2.17(r).
- COVER**
- 16. Final cover material is suitable in quality, of proper compacted thickness, and is applied and maintained where and when required to control vectors, fires, odors, blowing litter, and scavenging. 360-2.17(c). *See sheet 3 of 3 for areas of deficiency.*

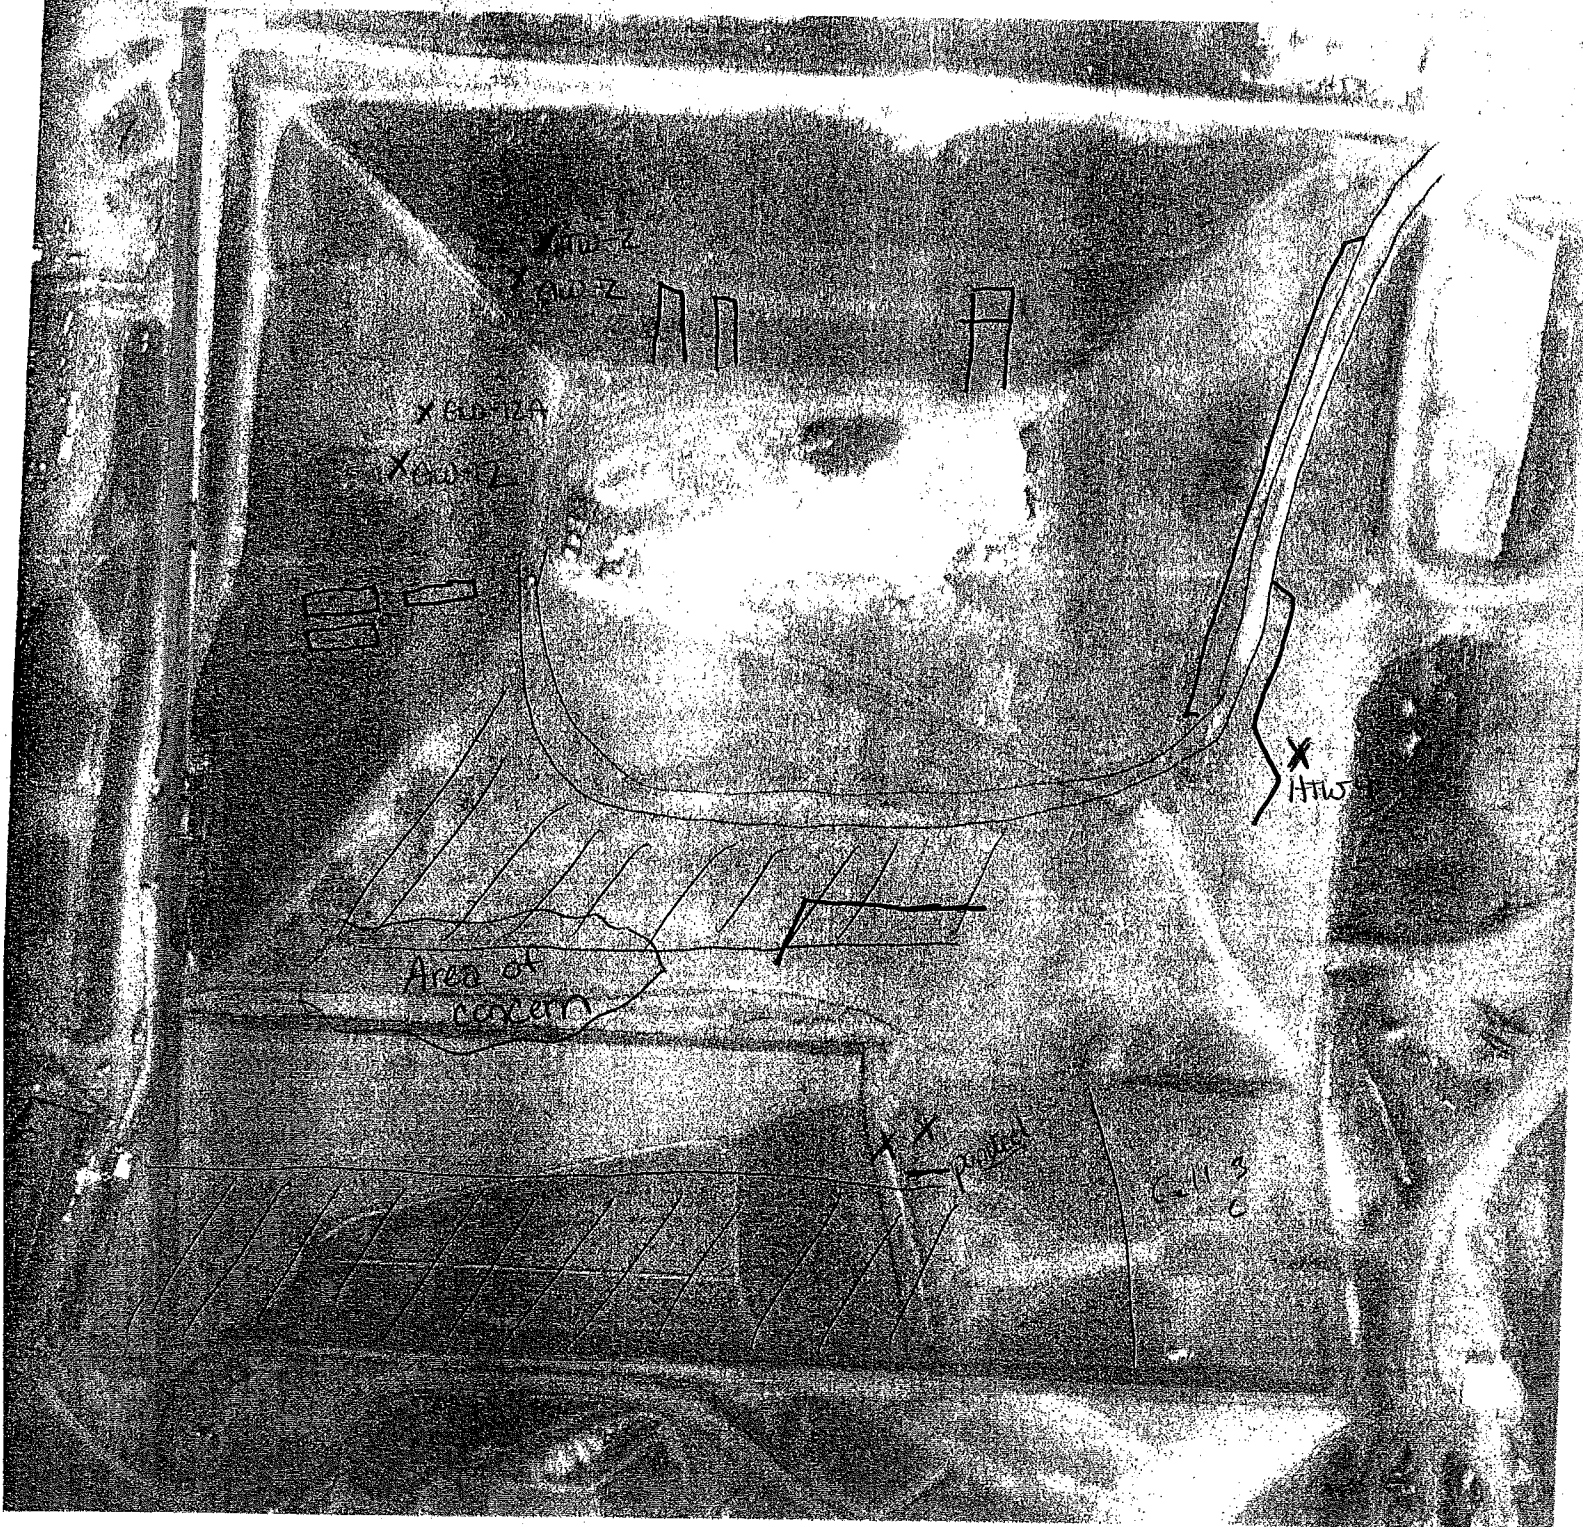
## Leachate Breakout / Fugitive Gas Inspection

- Breakouts found: (See map)
  - 1 on East slope above HTW 9-2
  - South slope 2 seeps found below horseshoe, some penced suspected areas along road going up into Cells 1+2 and in area above tire crips.
  - 2 on west slope, one below GW12-A and one near GW12
  - North slope right above HTW-2 and right below GW-2

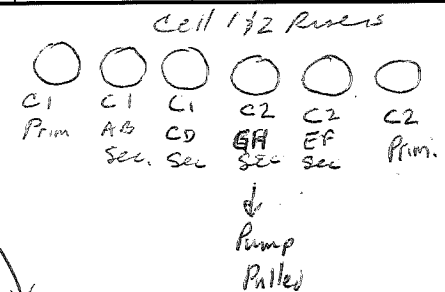
*↑ note stick reads 6" Low*

*↳ leachate level up to bottom of U @ top of its incline*  
*Pro Control reading is erroneous*
