02S17 Hyland Landfill
Monthly Mon Rpt 2013

Monitoring Report

Facility Name: Hyland Landfill
Facility Number: 02S17
Date: May 3, 2013
Reporting Period: April, 2013
Facility Monitor: Beverly Lewinski (BL) B.L.

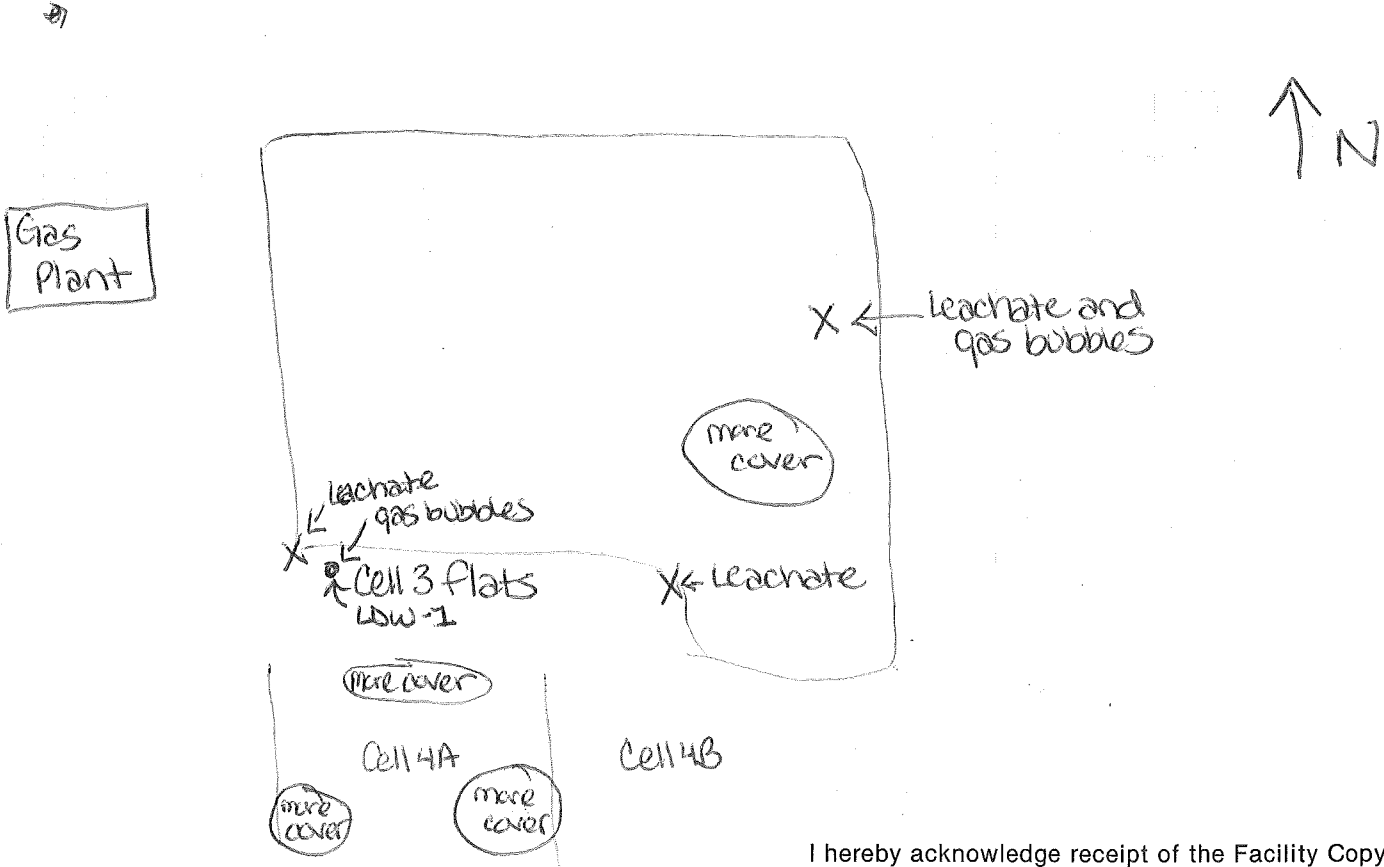
- need to get rid of ponded water atop Cells 1 and 2
- Leachate breakouts and gas bubbles on east slope below roadway going up landfill
- South slope had leachate flowing out of dirt in horseshoe area.
- Gas bubbles and leachate near LSW-1 on south slope
