Monitoring Report

Facility Name: Hyland Landfill

Facility Number: 02S17

Date: December 31, 2012

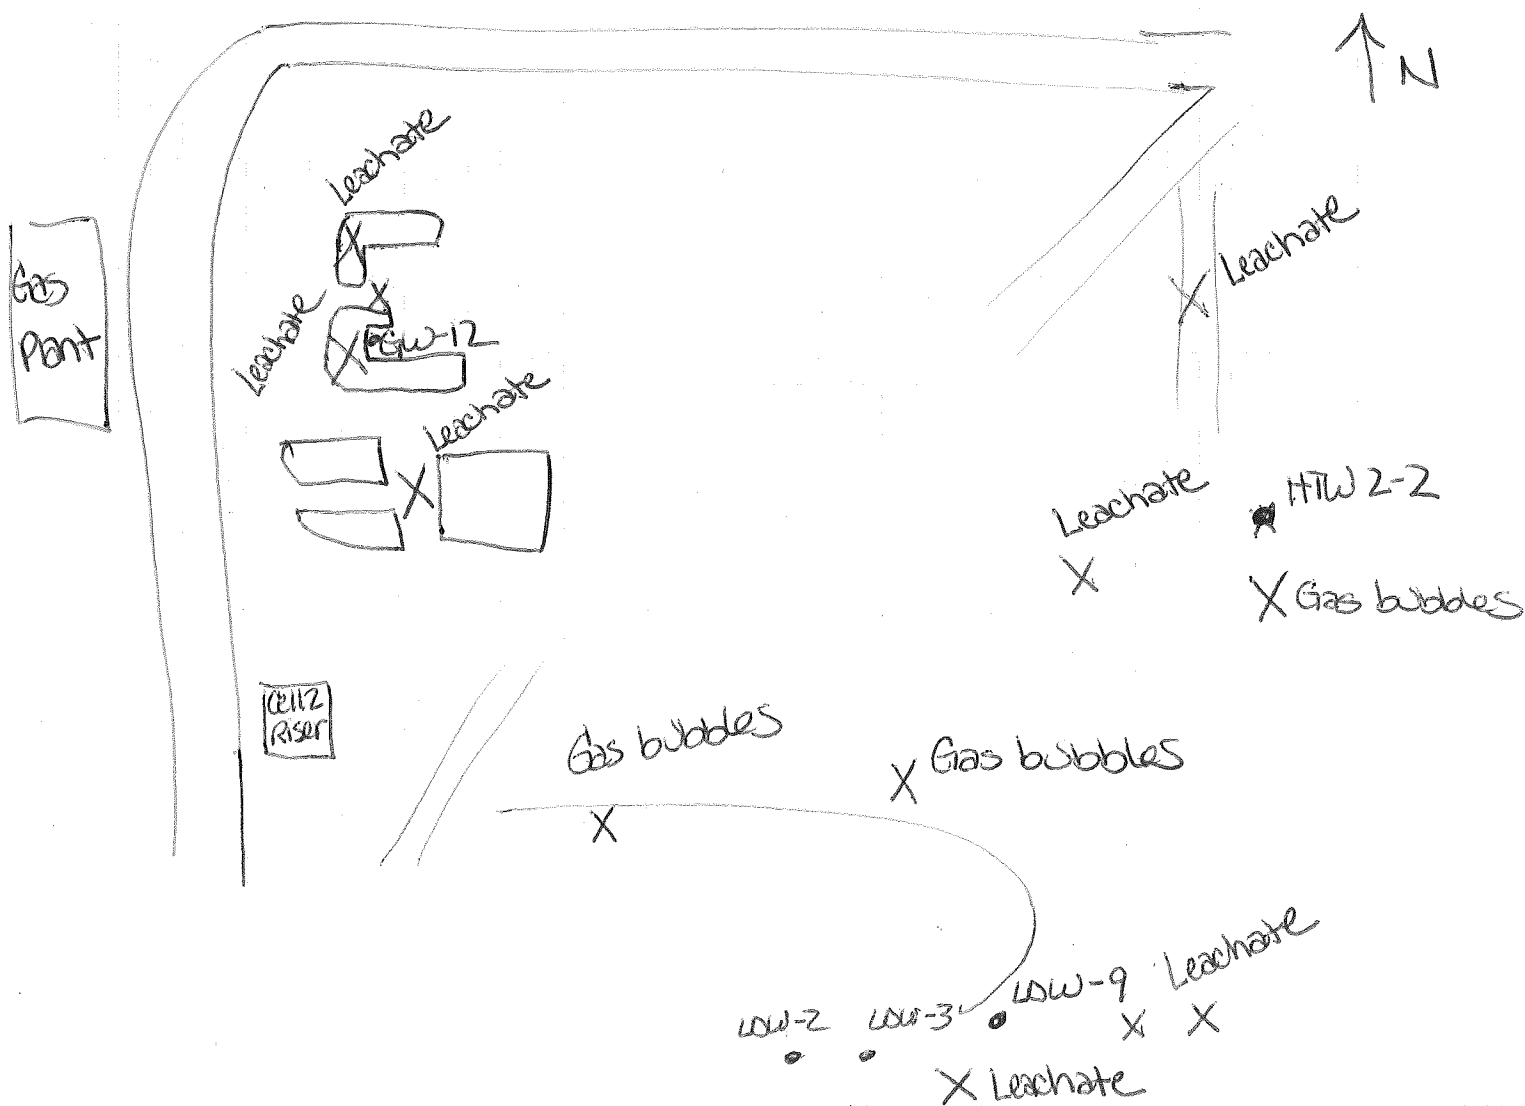
- need to go back and finish repairs once ground freezes or it dries out

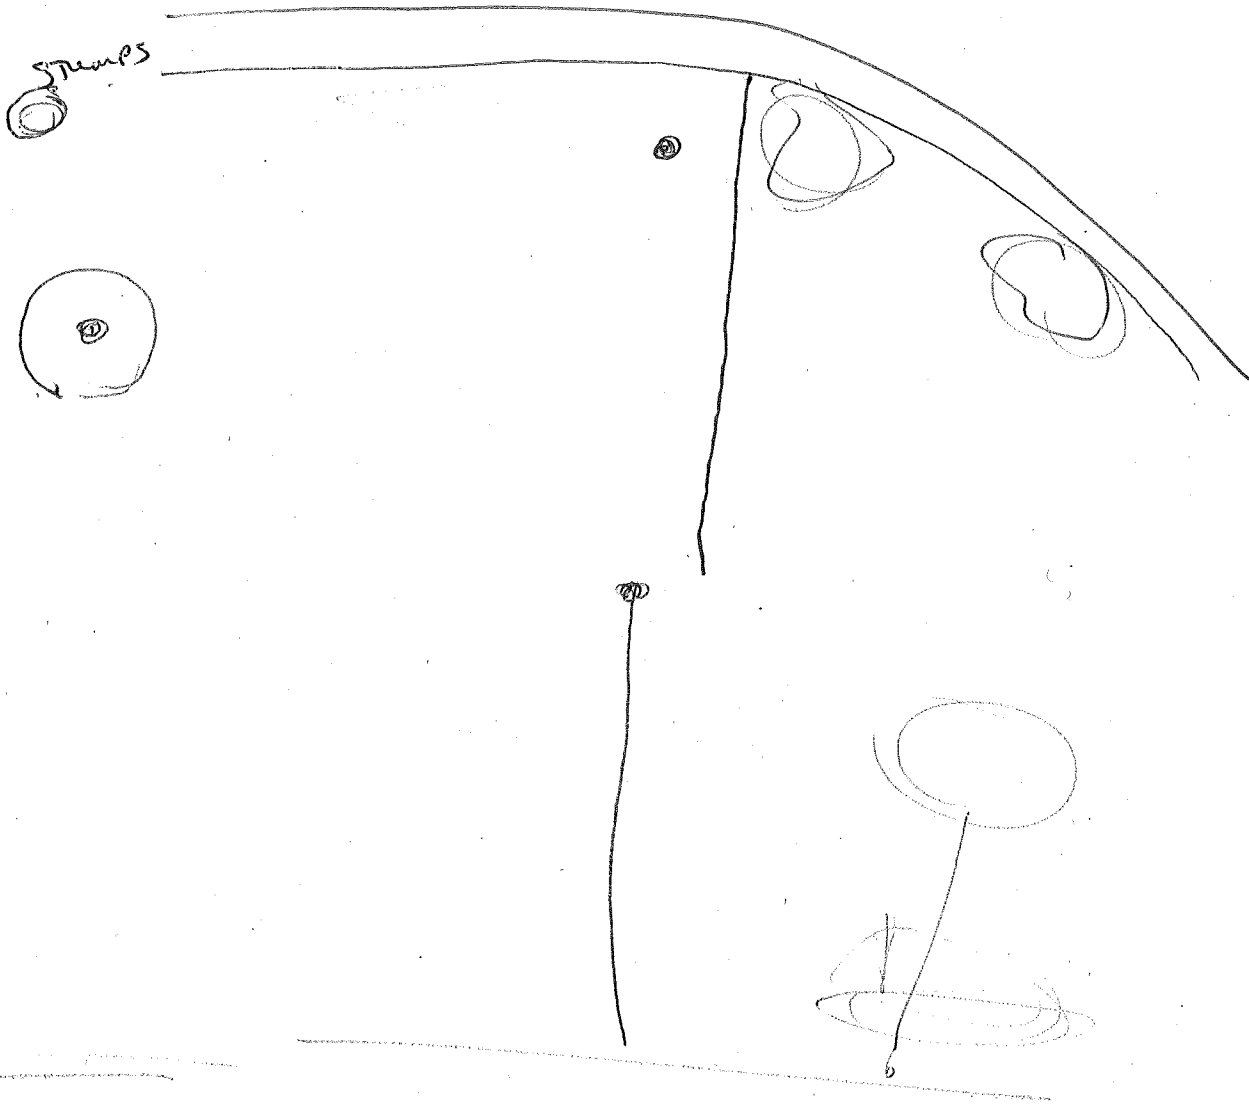
5' trench keyed into cell 4A from south slope. 5' trench keys into 20' trench from corner of south slope by cell 2/3. 20' and 5' trenches are ~~the~~ filled with tire chips to promote drainage. New french drains to be constructed to tie into existing drainage to remove/eliminate ponding @ toe of cell 2 slope. Drains to be installed by Memorial Day. Open trench along base of slope to be filled in this weekend. - Pools of leachate need to be eliminated, litter situation is very good. No issues.
